Dutchwest (2460, 2461, 2462) Sticking Bypass Damper

Dutchwest Convection '93 Series Service Procedure

1993 AND LATER DUTCHWEST CONVECTION HEATERS

Models 2460 (Small), 2461 (Large), 2462 (Extra-Large)

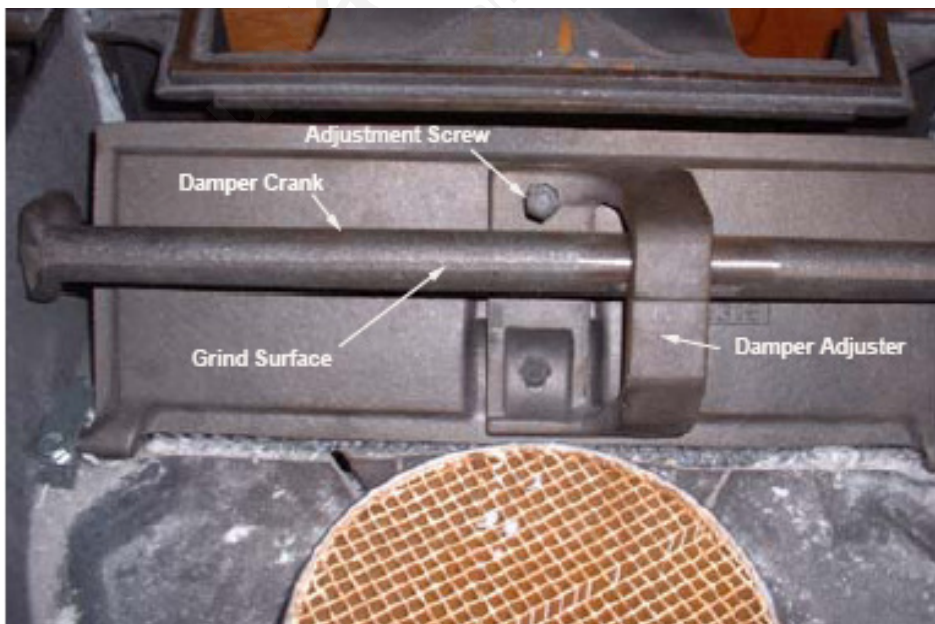
Damper in open position held in place by the damper adjuster. See view of damper crank showing the grind surface which contacts the adjuster when rotated down.

- 1) Damper adjustment screw oriented too far down pushing the crank too high. Back off the adjustment screw and operate the damper to ensure it closes, locks and holds the damper in the open position.
 - 2) Grind surface on the damper crank where the crank contacts the adjuster ramp to lock is not ground down enough. File or grind down the crank slightly to allow the crank to lock smoothly on the damper adjuster ramp. Check operation.
- It should take a slight wrenching affect on the damper handle to lock or unlock the damper.

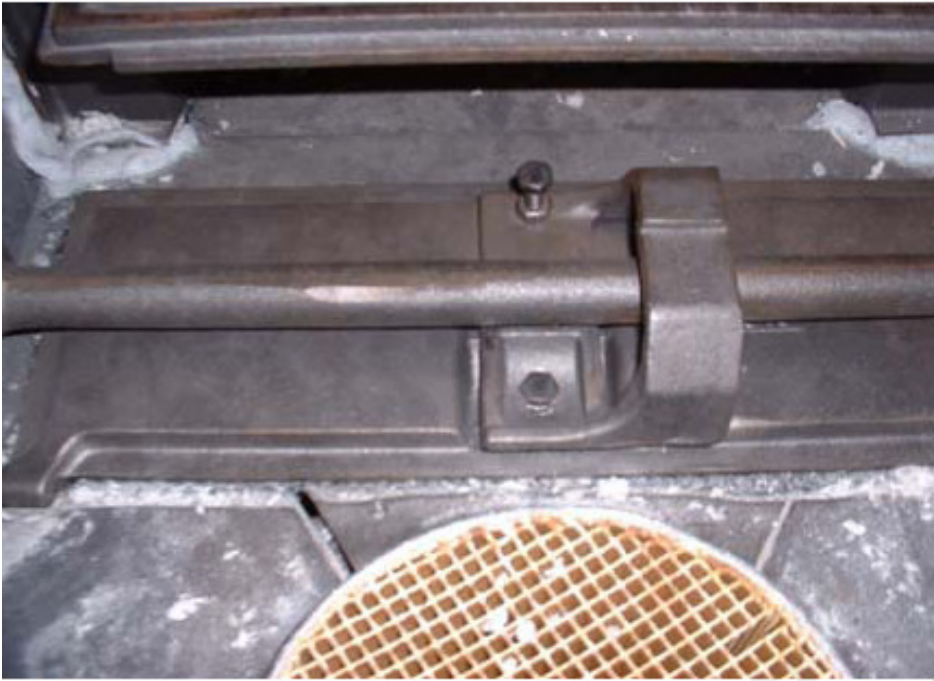
Damper in closed position with the damper crank rotated to locked on the damper ramp of the adjuster.
