# Inner Top Replacement and Repair Instructions for the Seneca, Sequoia and Convection Heaters

The two-piece inner top for the Dutchwest stoves has a removable web at the rear of the opening for the catalytic combustor. The two piece construction relieves thermal stress by allowing expansion and contraction of the cast iron parts as the stove heats and cools.

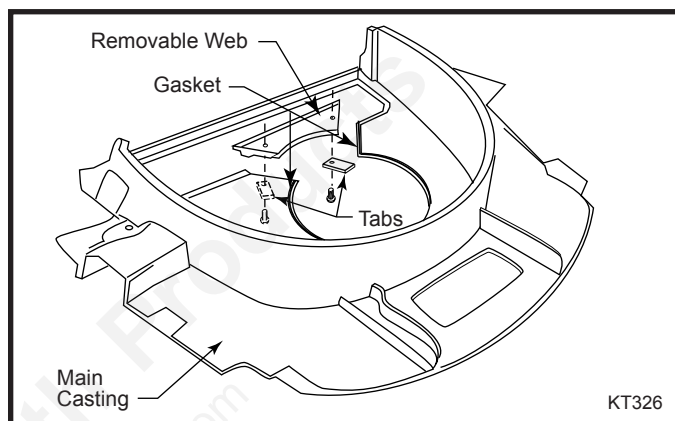
Fig. 1 Top side of two-piece inner top.

You may see a gap between the ends of the web and the main casting. There is a gasket in the gap. This gasket is an "Interam" type which is small and flat when new; during the first fire it will expand to several times its original thickness, and seal the gap. This light, but dense gasket promotes compressibility to the seal, thus letting the web expand under heat without damage.

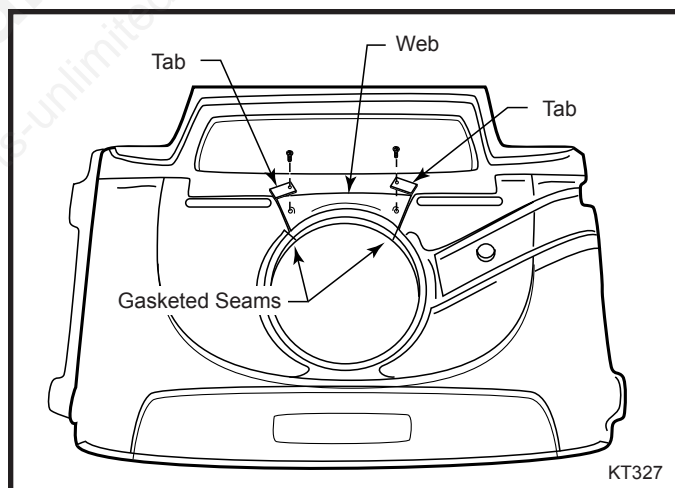
Fig. 2 Under side of two-piece inner top.

The web is held in place by screws that pass upward through damper tabs into the bottom of the web.
